British WW 1 18 Pound Quick Firing Field Gun

Irish Army Civil War Artillery

Condition report

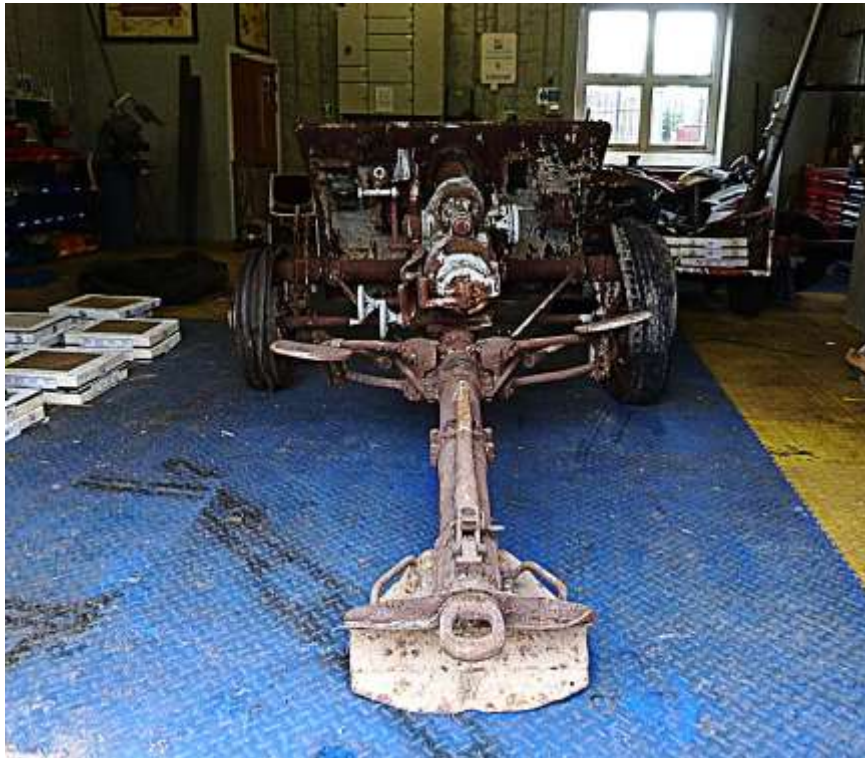
Figure 1 the gun in the location it was inspected for this report

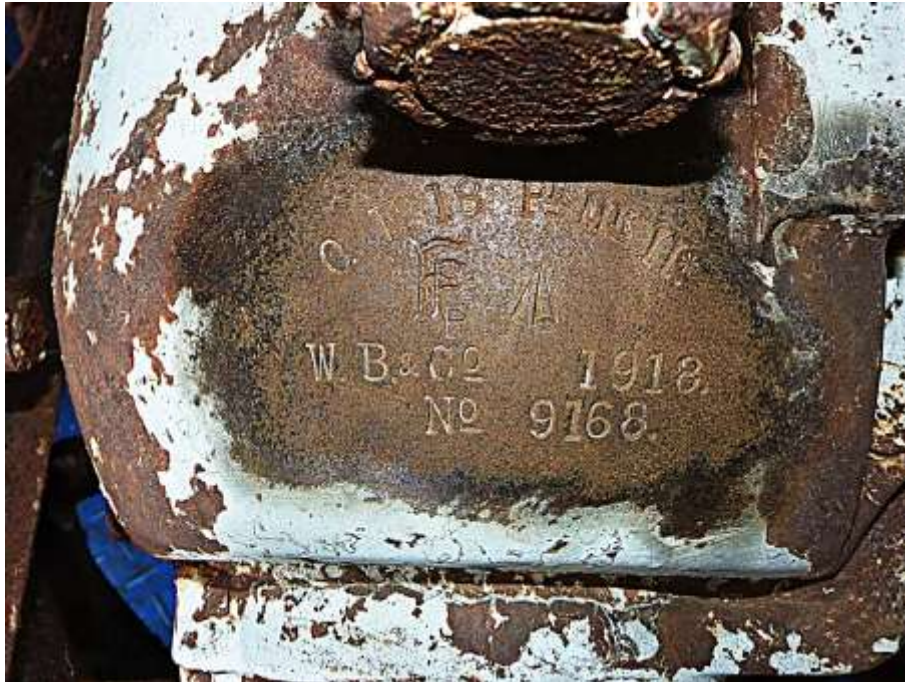
Figure 2 The markings on the breach

The gun has several markings and numbers on various parts of the gun, the most important markings and numbers are the on the breach end of the barrel as this gives us the maker, date and guns number. The other markings that are important in this area are the War department mark and the FF mark.

The gun is marked "Q.F. 18 PR Mk II*", this identifies the gun as a mark 2 quick firing 18 pounder. This is in the same font as the maker's name W.B. & Co. this is the well known maker of William Beardmore and Company Glasgow, after the maker's name there is the date 1918 this again is in the same font. Above the maker's name but below the type (Q.F. 18 PR Mk II*) there is the war department arrow mark to the left of the war department mark if the FF for Fianna Fail mark this is in a different font and is a later addition to the gun and appears not to have been added recently. There are two letter "P" added in this area both of different sizes one appears that it could be the same font as the maker's name the other is smaller. Finally, in this section under the maker's name is the number of the gun "No. 9168". See figure 2 for illustration of the markings. These markings in the breach area are in good condition for age and considering the gun has been exposed to external environmental conditions for a number of years, there is some loss of sharpness. This loss of sharpness will increase during conservation treatment when the corrosion is naturalised.

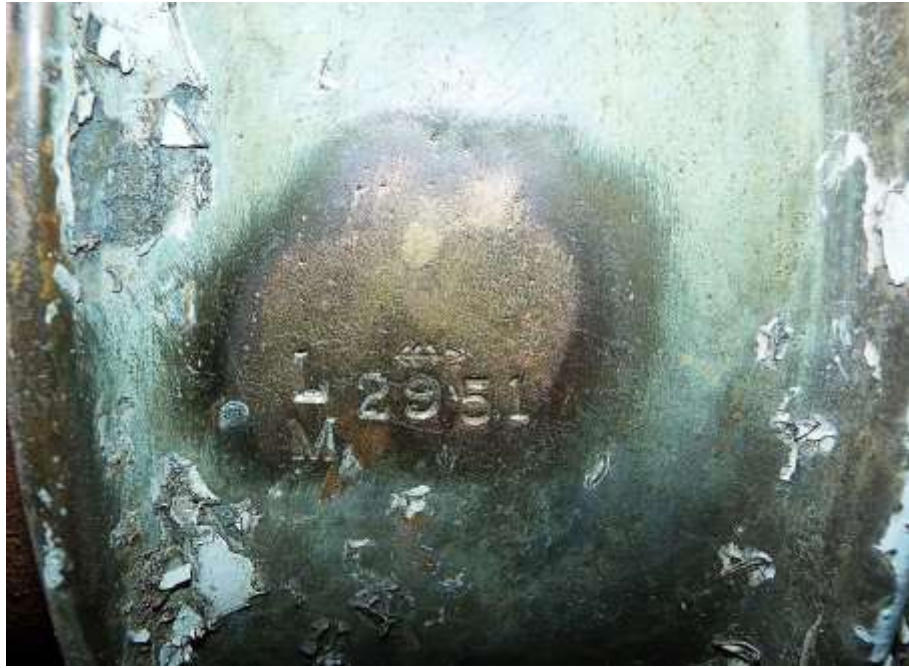
Figure 3 an example of markings on the gun.

There are also markings on other parts some of these are difficult to see as the corrosion is severe in some places most of these markings will be part numbers and dates. The condition of these markings will vary depending on the amount of corrosion present at each location of the markings. These areas with markings will need sensitive conservation treatment as explained in the treatment proposal methods. Blast media of any kind should not be used in these areas; also blast media should not be used on brass in any situation.

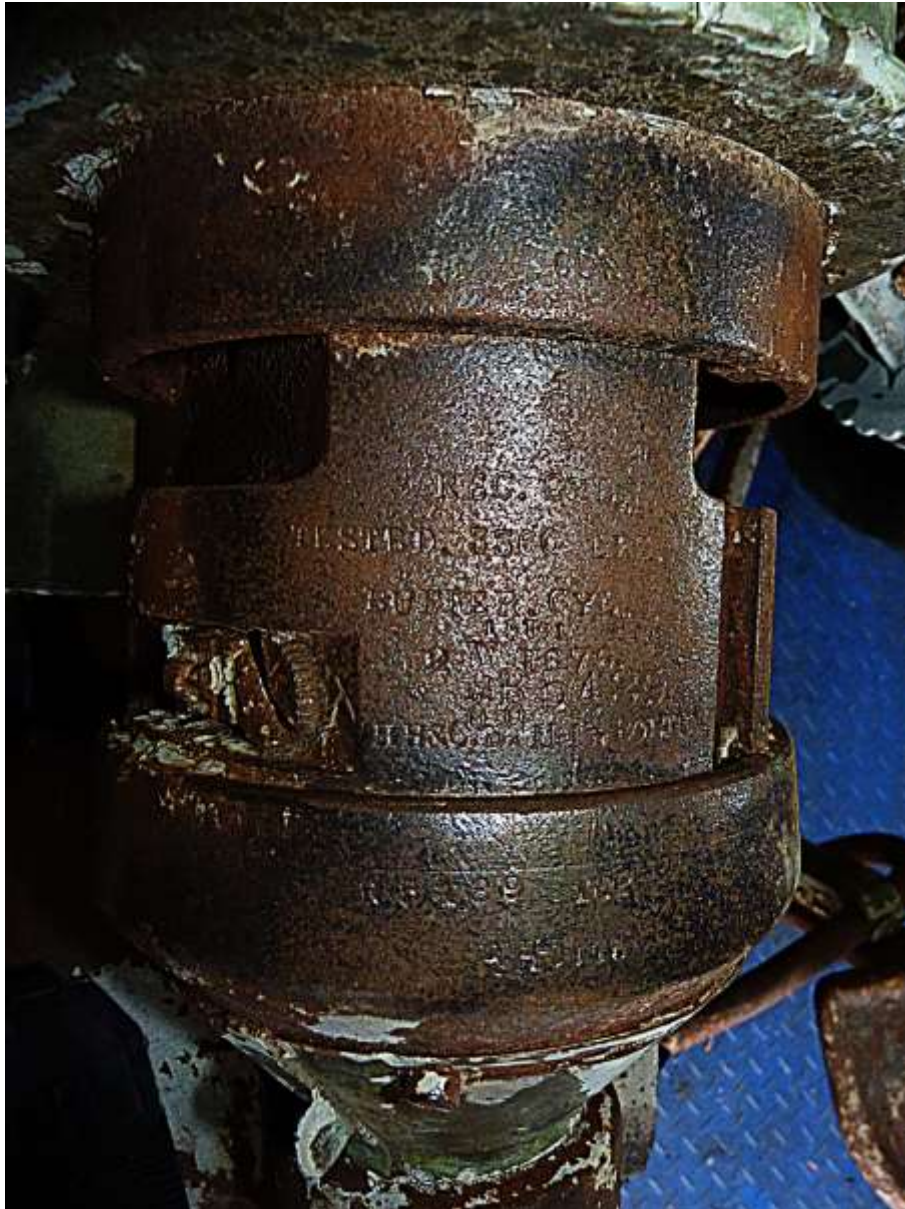
Figure 4 the markings on the recoil.

The recoil is an area that has markings of interest; these markings indicate that the unit has been tested although this is at time of manufacture. There are other markings in this section of recoil see figure 4.

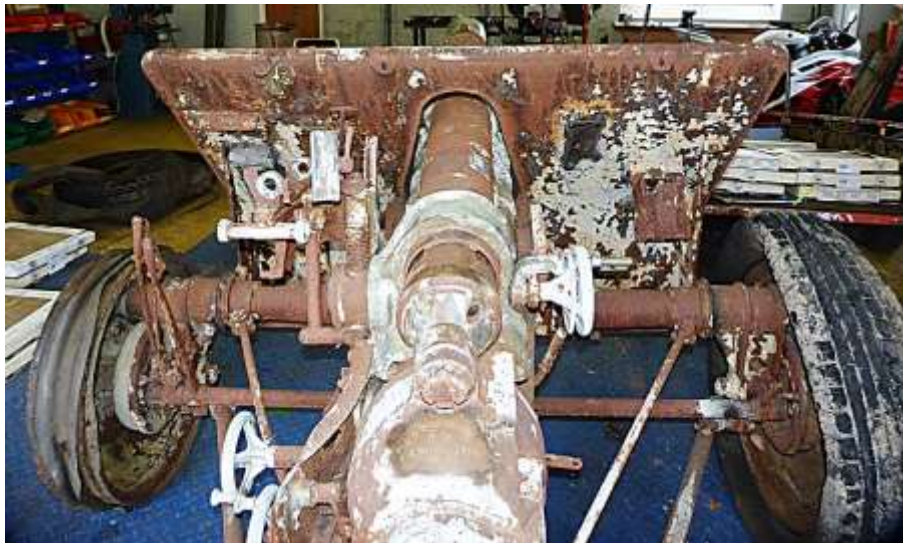
Figure 5 the gun from the trail

The gun is in an unfortunate condition and requires urgent conservation treatment starting with a professionally written treatment proposal in order to agree methods and create an order of works. The amount of treatment required is that a timescale of 18 -22 months with between 24-32 hours worked a week on the project would be realistic and longer if the hours are between 6-12 hours worked on the gun per week.

Conservation professionals would describe the guns condition as extremely poor; this is why the gun requires intensive time-consuming conservation treatment.

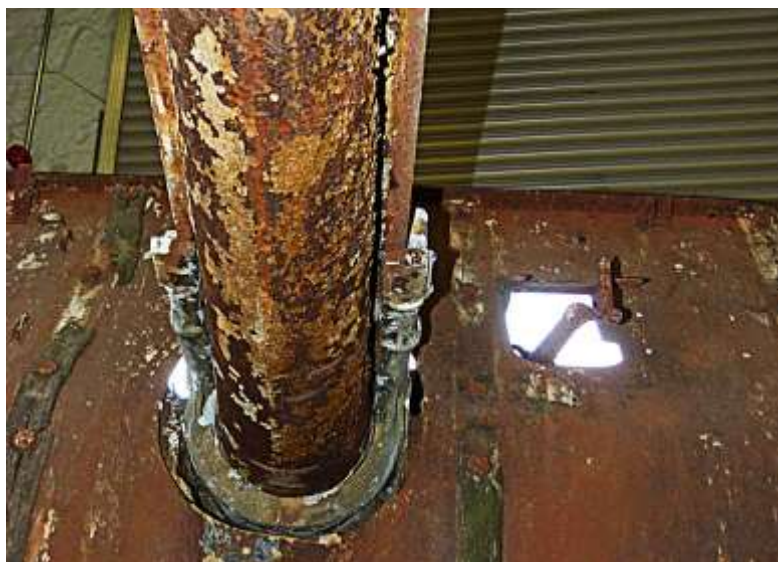
Figure 7 Close up of the underside of the barrel and shield showing the difference in corrosion intensity.

The poor condition of the gun is because in part the gun has been stored outside in inclement weather in Virginia USA where the average precipitation in this area is 43.32 inches per year and the average relative humidity ranges from 43% to 91% with most days above 50%. The suggested RH storage for uncoated metals is 40% (+or - 5%) RH. This average weather results in the creation of corrosion species of moisture and oxygen been regularly exposed to the gun combined with the degradation of the protective coating (probably an alkyd paint) and the little or no conservation treatments. This has let the gun become heavily corroded in many areas and the most of the moving parts to become seized as result of corrosion and the breaking down of the protective coatings. This rating of extremely poor condition with the current level of corrosion will mean that many of the conservation treatments required will have to be completed by hand. The corrosion has also caused permanent damaged as when the gun is treated there will be areas of pitting remaining, for example under the barrel the corrosion is intense and uneven however the lower area of the shield has more even uniform corrosion and will result in a more even finish when treatment is complete. However, even with this more even corrosion there is still the possibility that there will be pits left after treatment. (See figure 7)

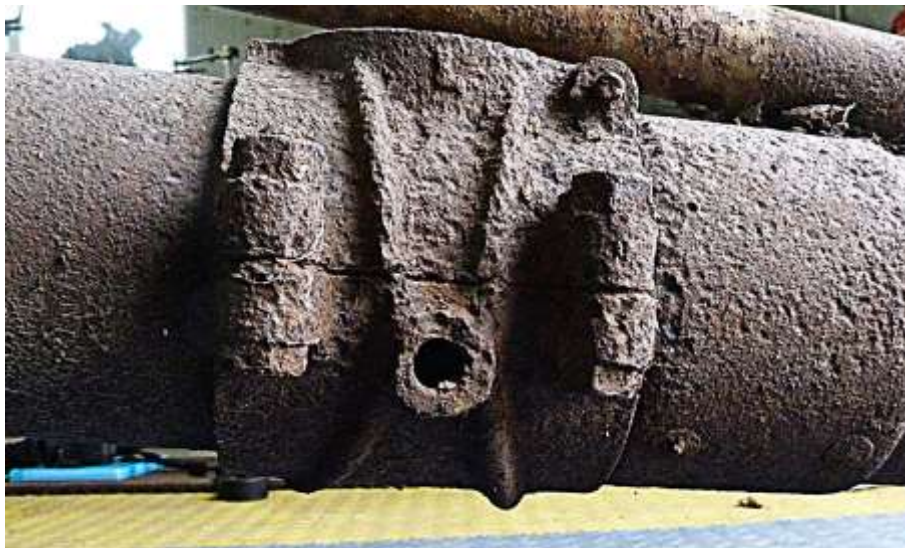
Figure 8 corroded part with damaged fastenings.

The parts seized by the corrosion will also result in disassembly issues during treatment as the corrosion has created wear on nuts and bolts, also the corrosion on the threads will affect the removal of the part been removed this damage will result in unavoidable loss of material although this could be microns it is still not desirable. Fortunately, in this situation the nuts and bolts will be British standard imperial sizes that can be replaced, as this standard is still available. However, the will class the project as a restoration project as to a conservation project, this is acceptable but

replacement should be kept to a minimum, if this is to be done within industry standards of restoration ethics this replacement of nuts and bolts should not in this case of greatly affect the historic integrity or value of the object. (See figure 8)

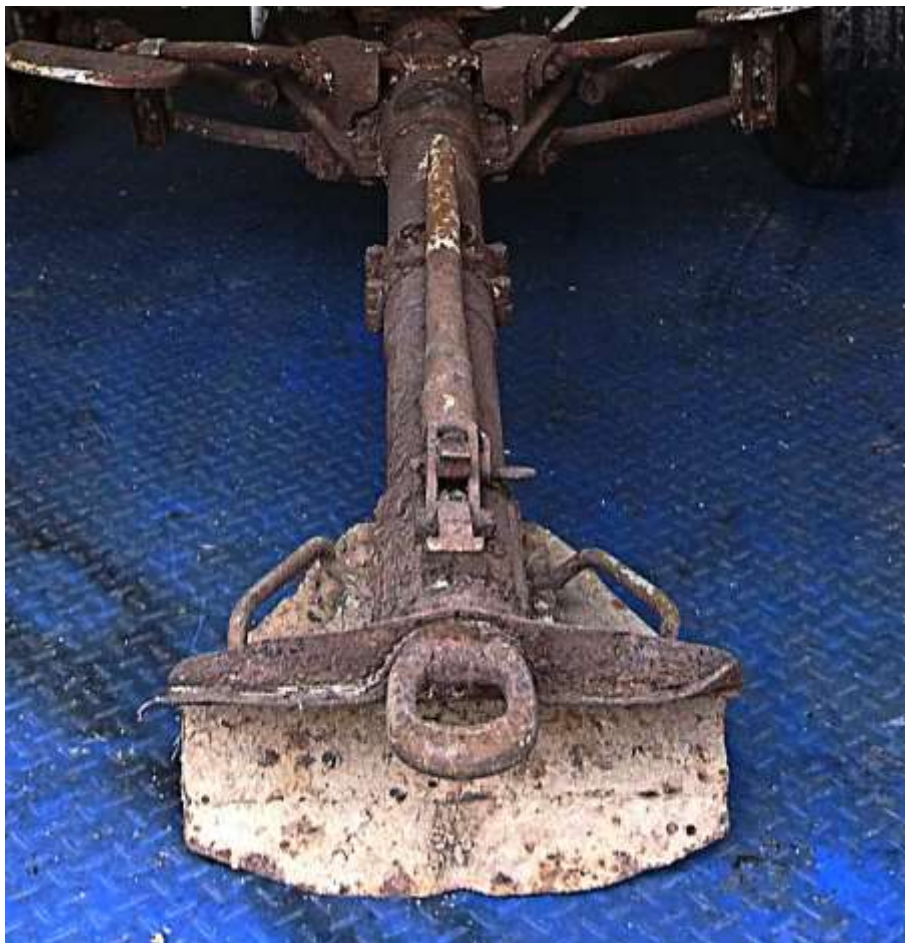
Figure 9 the trail

The trail has the previously mentioned corrosion issues. (See figure 9) The condition is not improved by the mud combined with roots that has been left on the end of the trail under the lifting brackets. (See figure 10) In this area there is a small steel plate although this appears to have enough material to conserve the level of corrosion is such that it might become apparent during treatment that the plate has corroded through. The rivets in this section also appear to be sound but there will be some material loss and this could leave the rivets slightly misshapen but this should be difficult to notice when viewing the object on display.

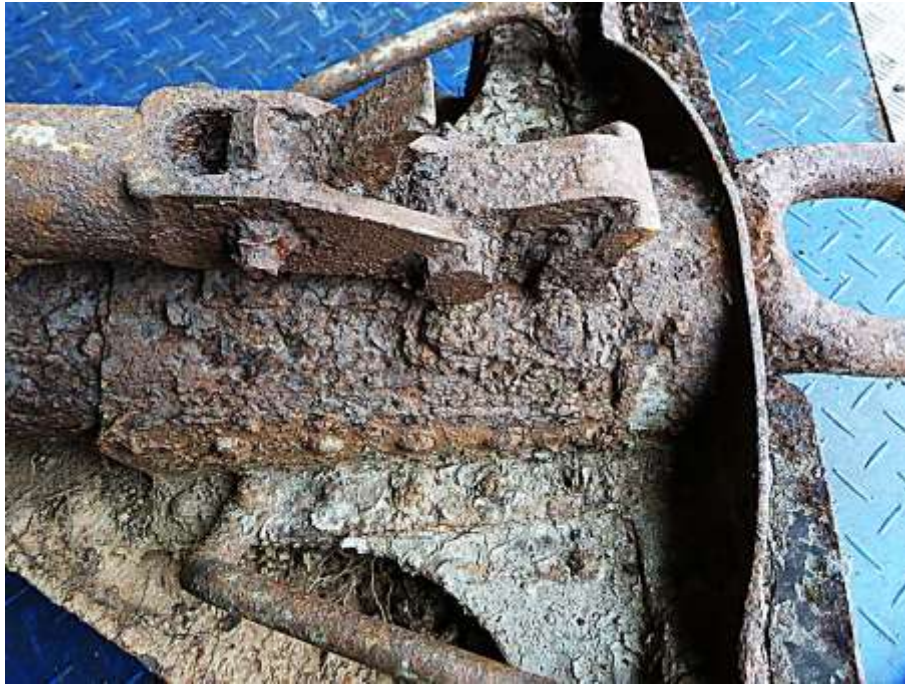
Figure 10 close up of the one of the lifting brackets mud and root visible

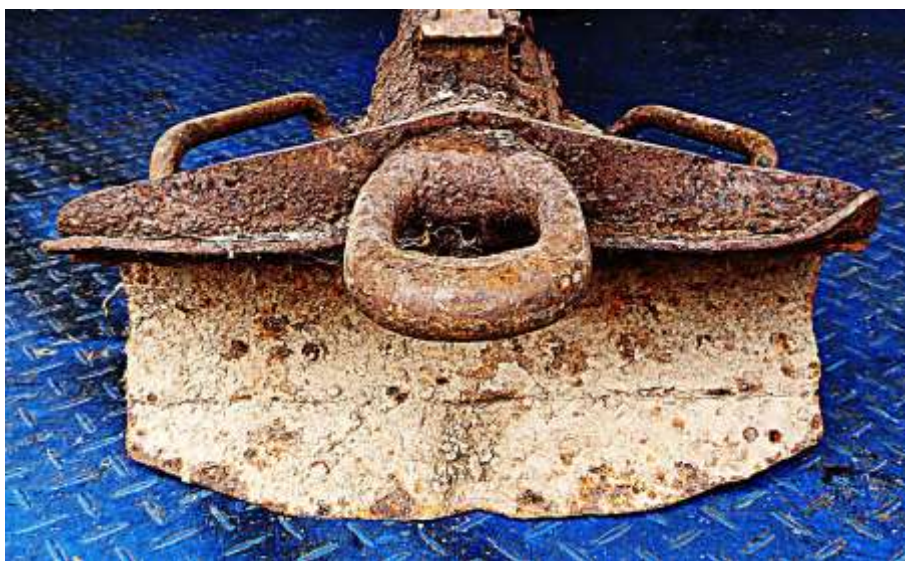
Figure 11 the end of the trail and towing eye.

The end of the trail including the towing eye is in a similar state with mud left on the surface; although the area is complete the condition is again affected by corrosion. The area in this section that is in the most degraded condition is the shaped steel plate around and each side of the towing eye. It is possible that water has sat in this area for prolonged periods and this has an increased the level of corrosion. The edges of the steel plate appear to have lost some definition through material loss. This might be more visible after conservation /restoration treatment.

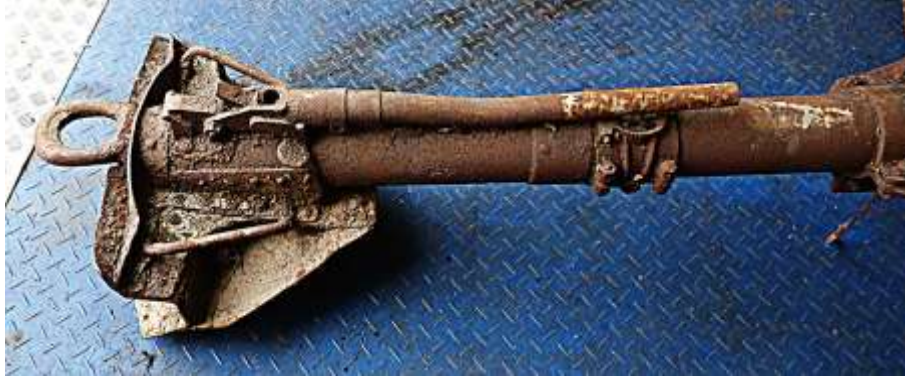
Figure 12 the trail from the side

The condition of the main tube is poor with more or less 100% corrosion over the surface area; in some areas this is heavily pitted. The pitting will remain after treatment as it is considered unethical to fill in pitting in conservation and restoration. Treatment as suggested in the treatment proposal completed by the Royal Armouries will improve the condition to good when treatment is complete. (See figure 12)

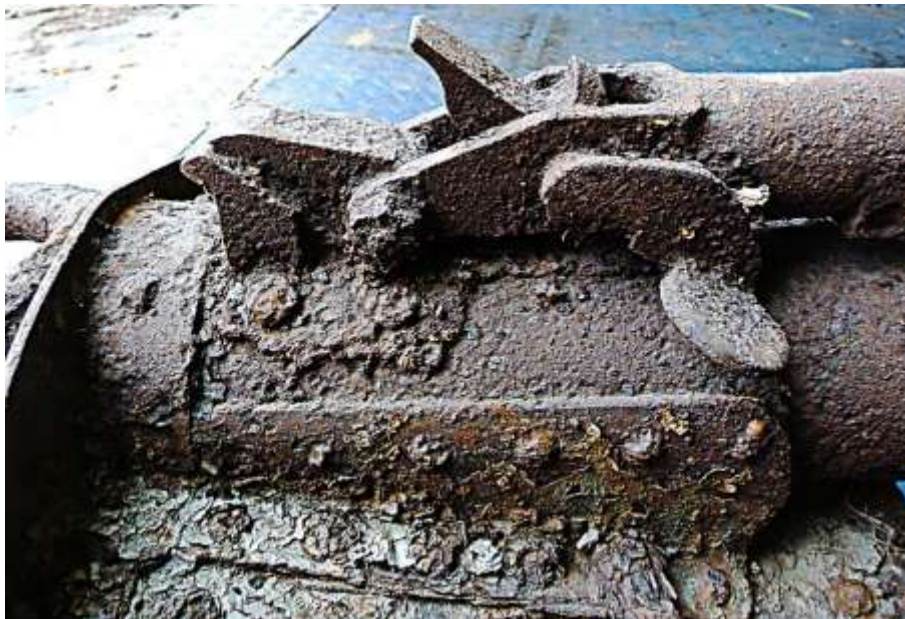
Figure 13 Close up of the trail lift lever fitting.

The trail lever fitting is also completely covered in corrosion with a fair amount of pitting over the surface. The plate that joins the lifting lever to the main tube by

rivets is present but in poor corroded condition. Care needs to be taken to preserve this fitting during treatment to keep the integrity of the gun. (See figure 13 and 14) An 18 PR with the lever welded on not using the rivet method is illustrated in figure 14.

The lever and lever locking mechanism on the Irish 18Pr are totally covered in corrosion and this will have seized the moving parts making the lever inoperable and therefore requiring intensive conservation treatment.

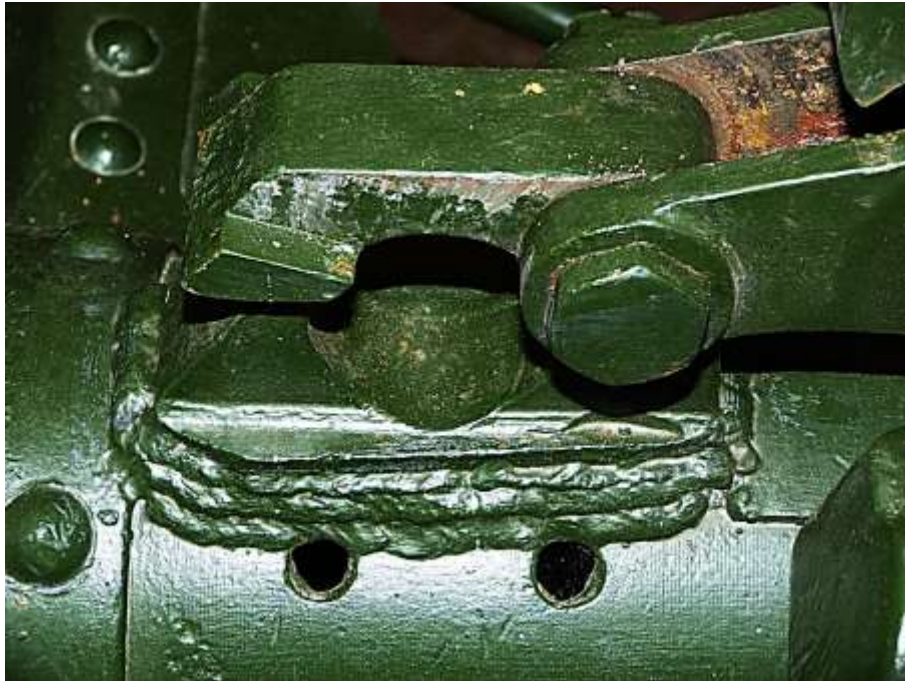
Figure 14 close up of a lever fitting welded back in place leaving the rivet holes open

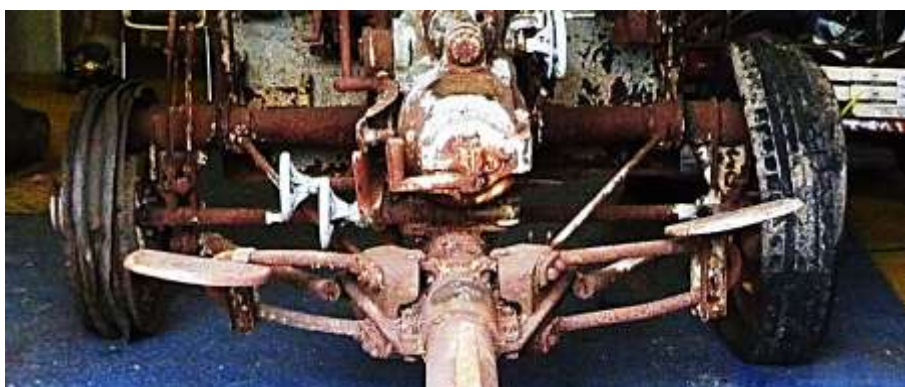
Figure 15 the pneumatic wheels

The wheels are not original and are a conversion to pneumatic tyres completed by Martin Parrey, this is a common feature with WW1 artillery and was often done at the time of the Second World War. The wheels can be converted back to replica cartwheels without effecting the integrity or value of the object. This because wheels were often replaced in the field during service, therefore, it would be unlikely to find a gun with the original wheels throughout the history of artillery.

The axletree has an even layer of corrosion over the entire surface and some pitting most of this appears to be not too deep into the material. (See figure 15)

The condition of the pneumatic wheels and associated parts including the breaking system is poor a corrosion rate of near 100% of surface area is present, if the moving parts are not seized then they are moving dry without lubrication, running dry for long periods of time will cause damages to the wheel system. The tyres are both in poor condition and the only solutions if the pneumatic wheels are to be displayed is replacement or to have the gun blocked on stands if a purist conservation approach is decided upon. (See figure 15)

The stakeholder's intention is to convert the wheels back to cartwheels; this would be a pragmatic option for display context, as it would display the gun in the state at the time of the Irish civil war. If this option is taken then the pneumatic conversion should be kept in store at the same location as the gun.

An option would be to conserve the pneumatic wheels in their current state as a physical record of the guns condition before conservation /restoration and the conserved pneumatic wheels could be displayed with some interruption alongside the gun.

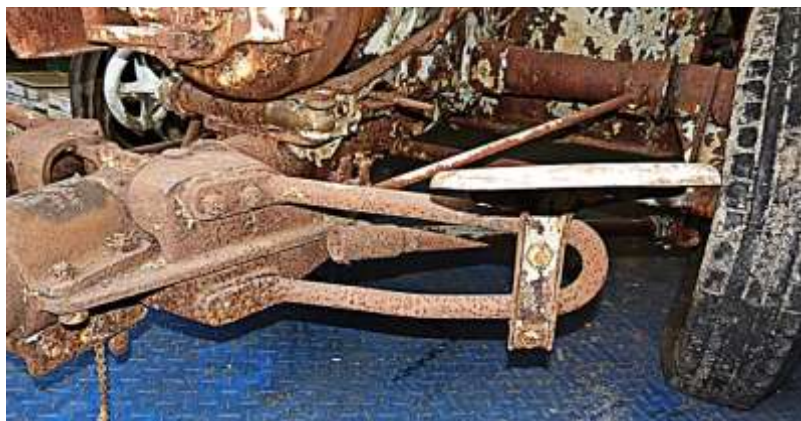
The condition of the fixings of the wheel system is poor because of heavy corrosion on most of the parts this might be the cause nuts and bolts to become misshapen. The unit will require careful removal to avoid damage. (See figure 16) This section includes the gunner's seats that are in a similar condition and will require removing and refitting if the wheels are changed along with the breaking system. (See figure 16)

Figure 16 the wheel and gunner's seat system

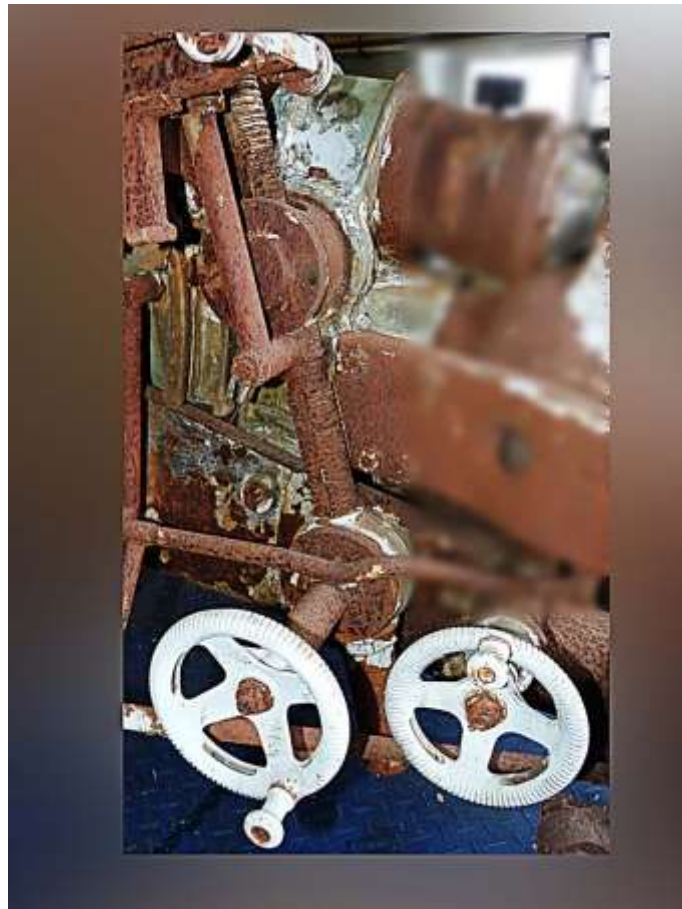
Figure 17 the elevating mechanism

The elevating mechanism is corroded with main screw in an extremely sorry state this would have been coated with grease or other lubricant during service and during the period of no conservation maintenance, the lack reapplication of this coating has caused the current condition. The coating when it degrades can also assist corrosion when combined with moisture and oxygen. (The Royal Armouries is currently conducting research in this subject). The main screw has lost some material because of the corrosion; therefore, the edges have lost some definition as this damage is permanent it could affect the efficiency of the mechanism. However, the gun is not to be returned to full service condition the mechanism can be treated to return to as near service condition as possible this would be acceptable for display and keeping the integrity of the gun.

The other moving parts are in a similar condition to the main screw and it is reasonable to suggest that the parts that cannot be inspected would be in a similar or slightly better condition. It should be noted that the hand wheel has been painted and there is little corrosion present this because they are possibly brass and will require brass conservation treatment. However, the holding nut and thread are steel

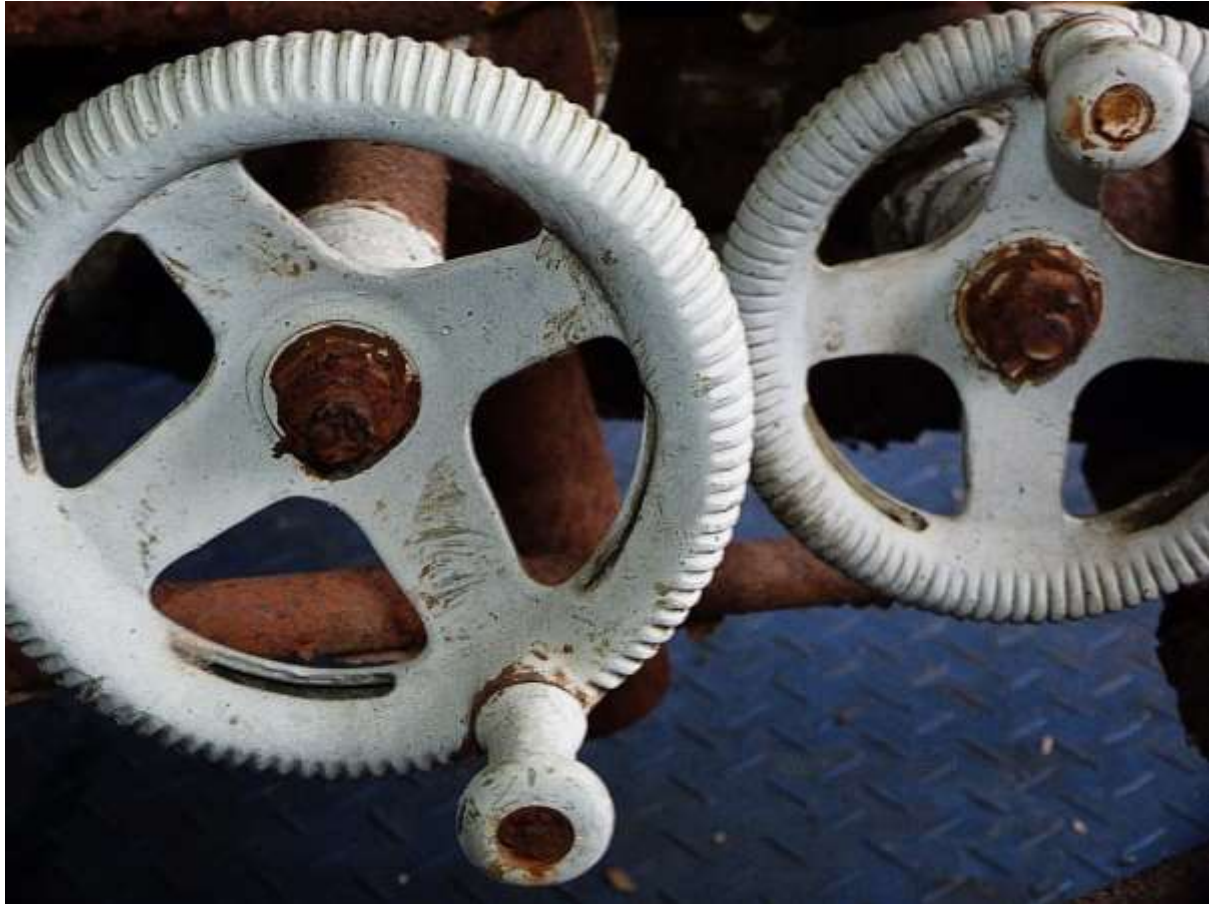
and in poor condition and require treatment; the nut is also misshapen because of corrosion damage. (See figure 18)

Figure 18 the hand wheels for the elevating and traversing mechanism

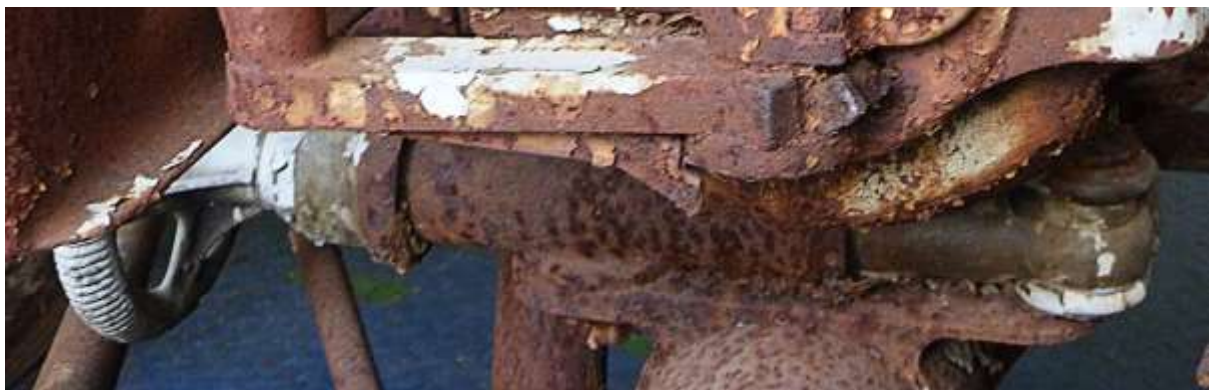
Figure 19 close up of the traversing mechanism

The traversing mechanism is in a similar condition to the elevating mechanism with the steel parts heavily corroded, some brass parts overpainted and moving parts seized up with lack of lubricant. (See figure 18 and 19)

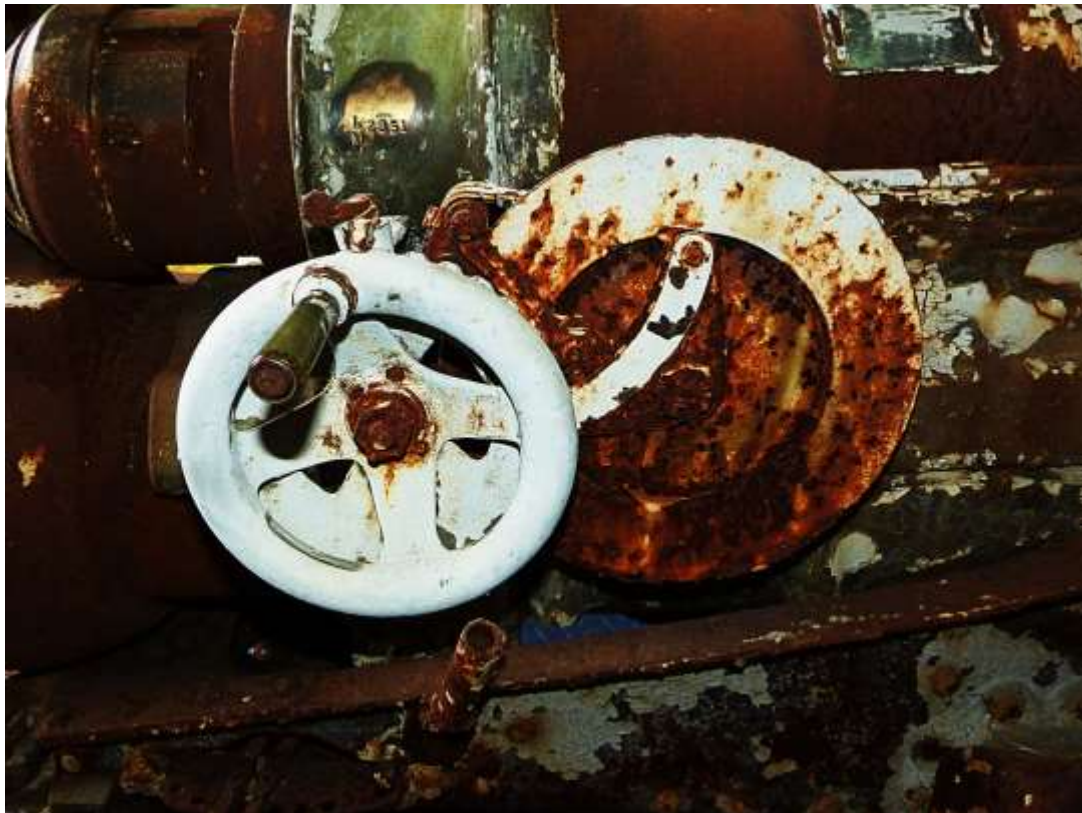
Figure 20 the elevating range scale

The range scale and hand wheel are in poor condition, the range scale steel wheel is corroded to such an extent that retrieving the scale might be beyond current conservation methods. If this is the case and with the level of surface pitting it would appear that it is, then a replica could be created for display and the current range scale treated and stored with the gun. (See figure 20 the elevating range scale and 21 a restored range scale on a different WW1 18Pr.) The bass arm with an elevating scale engraved on it should return to as near service condition with conservation treatment currently this is overpainted; therefore; the condition rating is poor, the same goes for the hand wheel on elevating range scale mechanism.

The moving parts are seized and again the fixings will have suffered from corrosion and will require treatment to improve the condition from poor to display or as near service condition.

The hand wheel paint is different to the rest of the gun it should be noted that this could be original paint and would require researching the paint colour could be the colour of the gun during the Irish civil war.

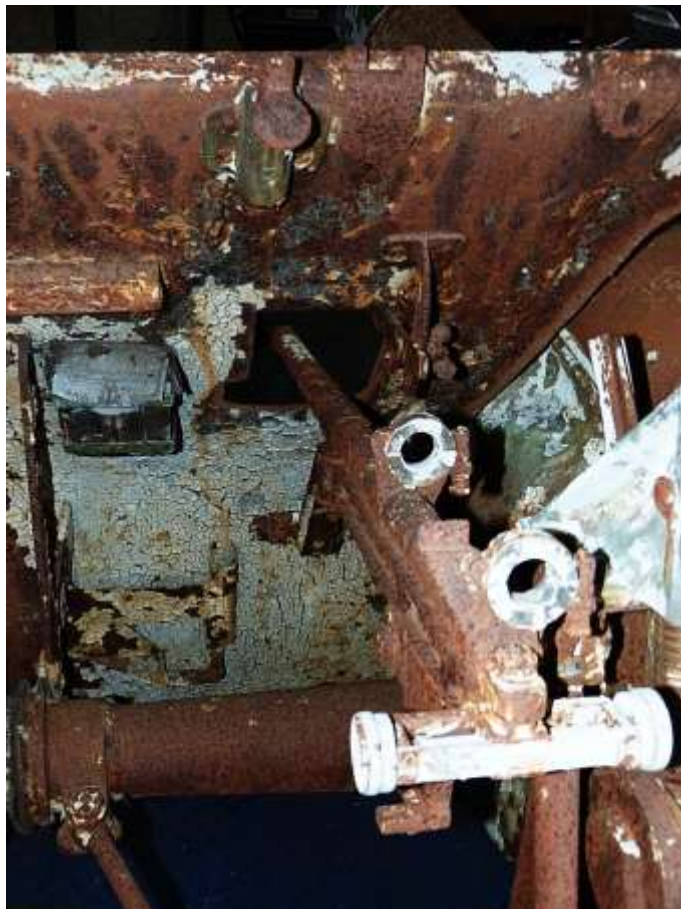
Figure 23 the sight rests.

The sights rests are in poor condition similar to the range gauge mechanism with steel parts heavily corroded and the brass parts heavily overpainted. The same treatments as the range gauge mechanism to improve the condition of these parts to museum/historic object standard is required. (See figures 23 and 24 for conserved sight rest on a different 18Pr)

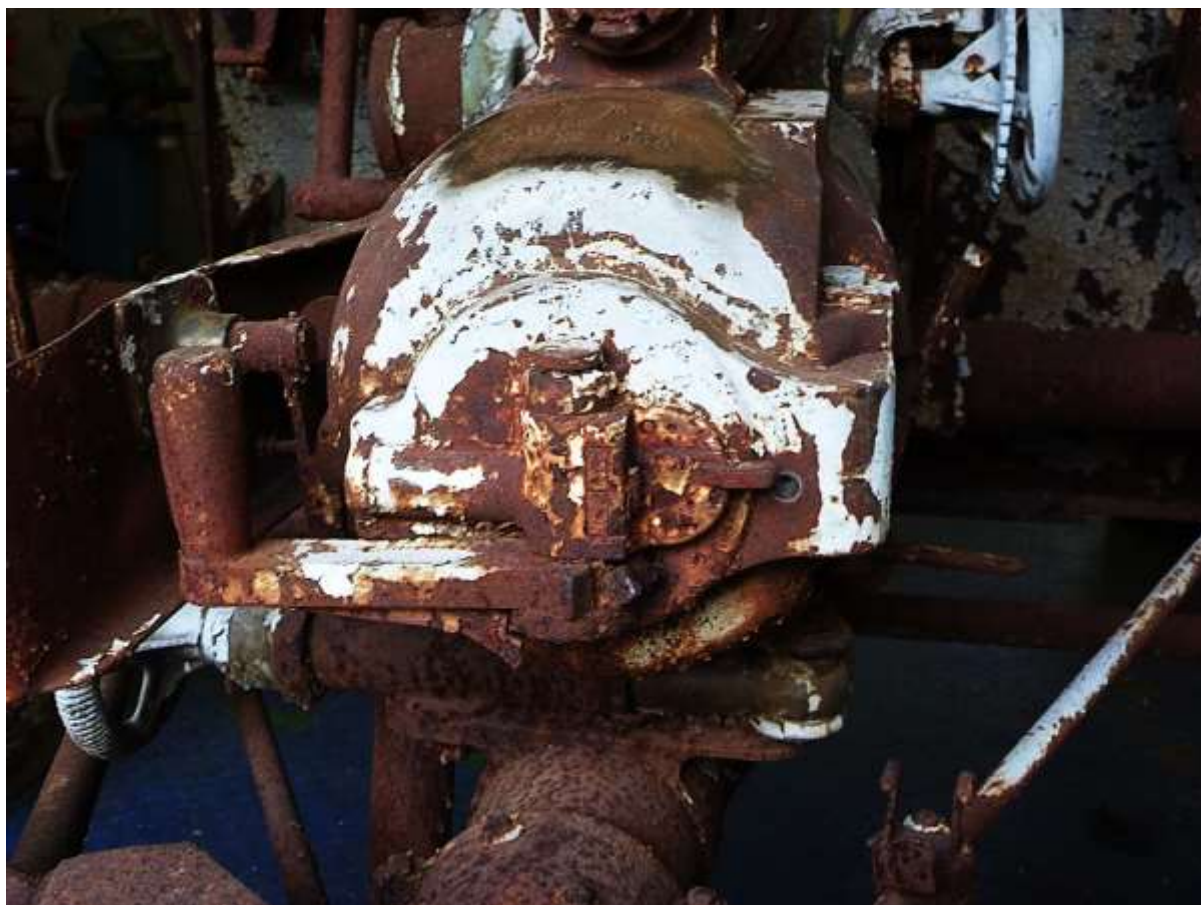
Figure 25 the breach

The breach and firing lock has the corrosion issues that are present on the rest of the gun as previously discussed; these are the degradation of the protective coating and the formation of advanced corrosion, and these issues result in seized moving parts. (See figure 25) Another issue is that the breach has been welded closed this has possibly been done to deactivate the gun. If this is the case there are other methods of deactivating the gun to improve the condition it would be advisable to consider reversing this weld. (See figure 26)

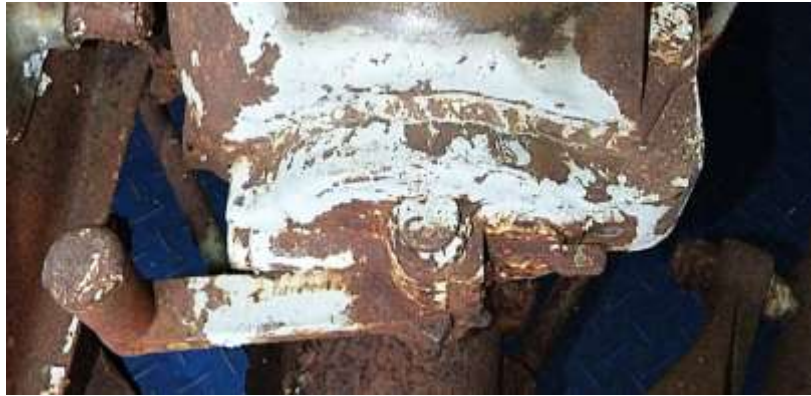
Figure 26 the breach with the welded

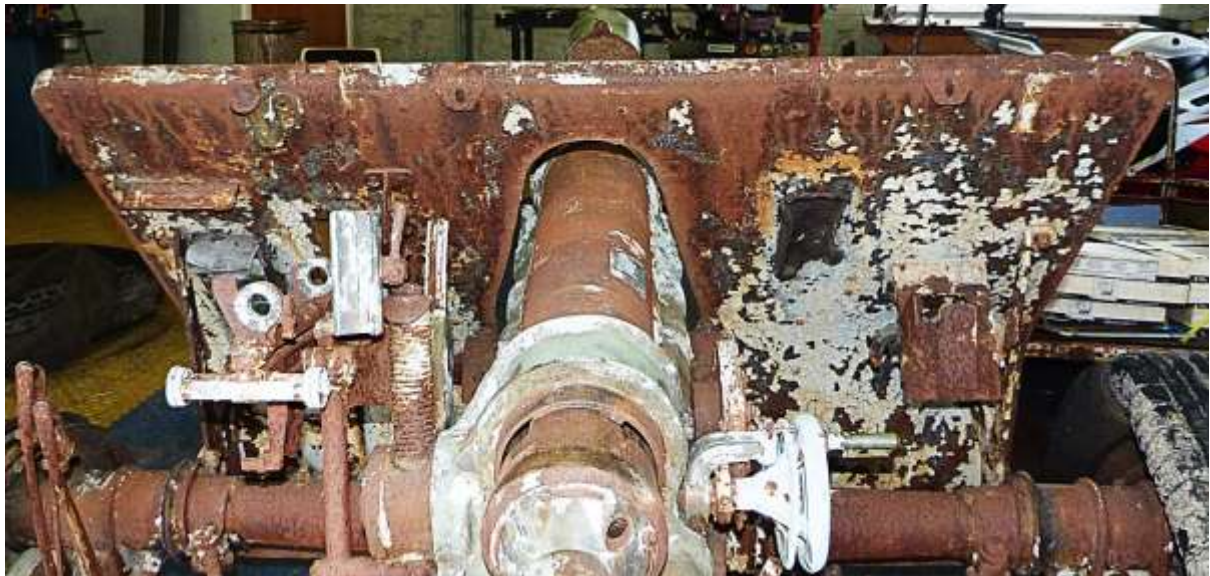
Figure 27 the back of the shield

The back of the shield is in poor condition with both corrosion and flaking paint across the surface, the leather fittings on the proper right side degraded and on the left is complete apart from the clasp on the pouch, but are in poor general condition. (See figure 27 and 28)

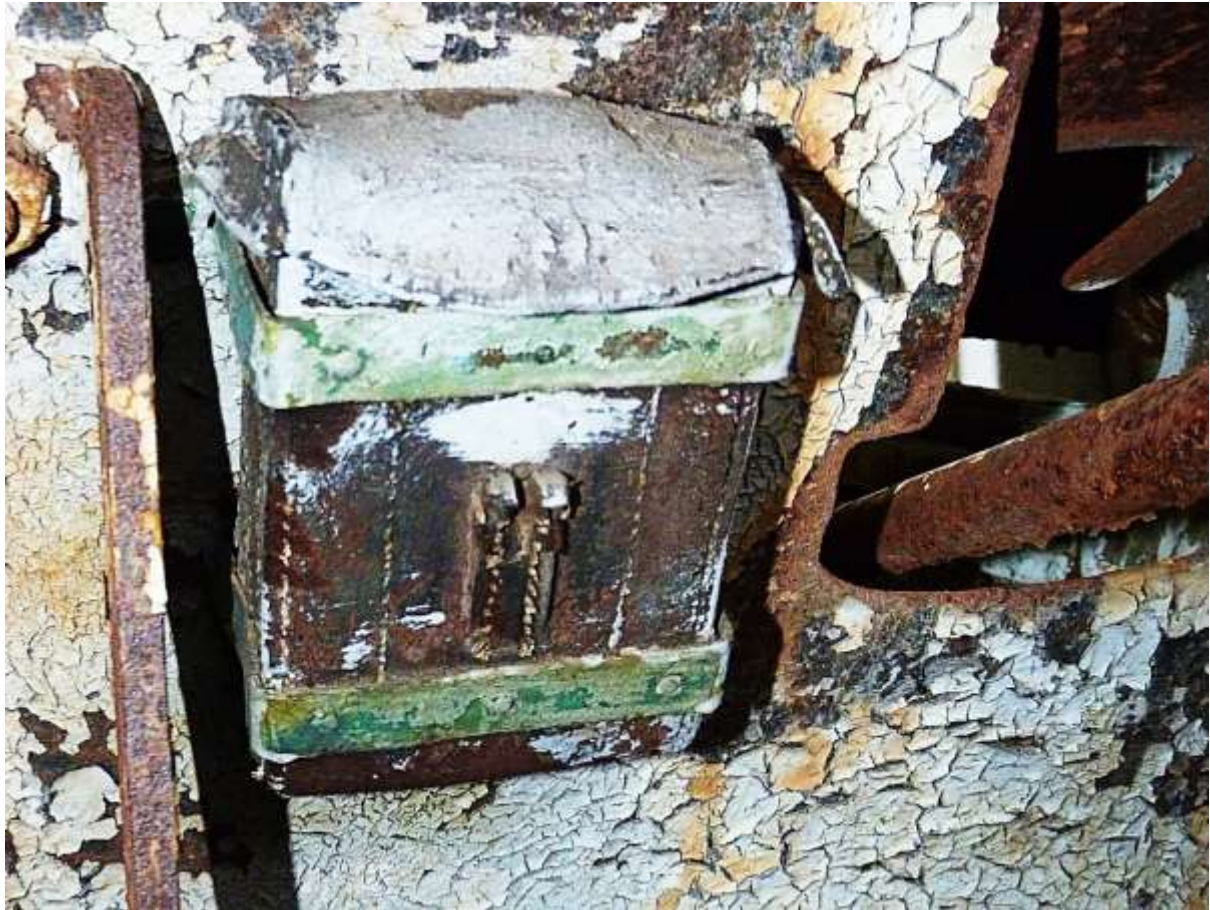
Figure 28 close up of the leather pouch on the proper left side and the damaged paintwork

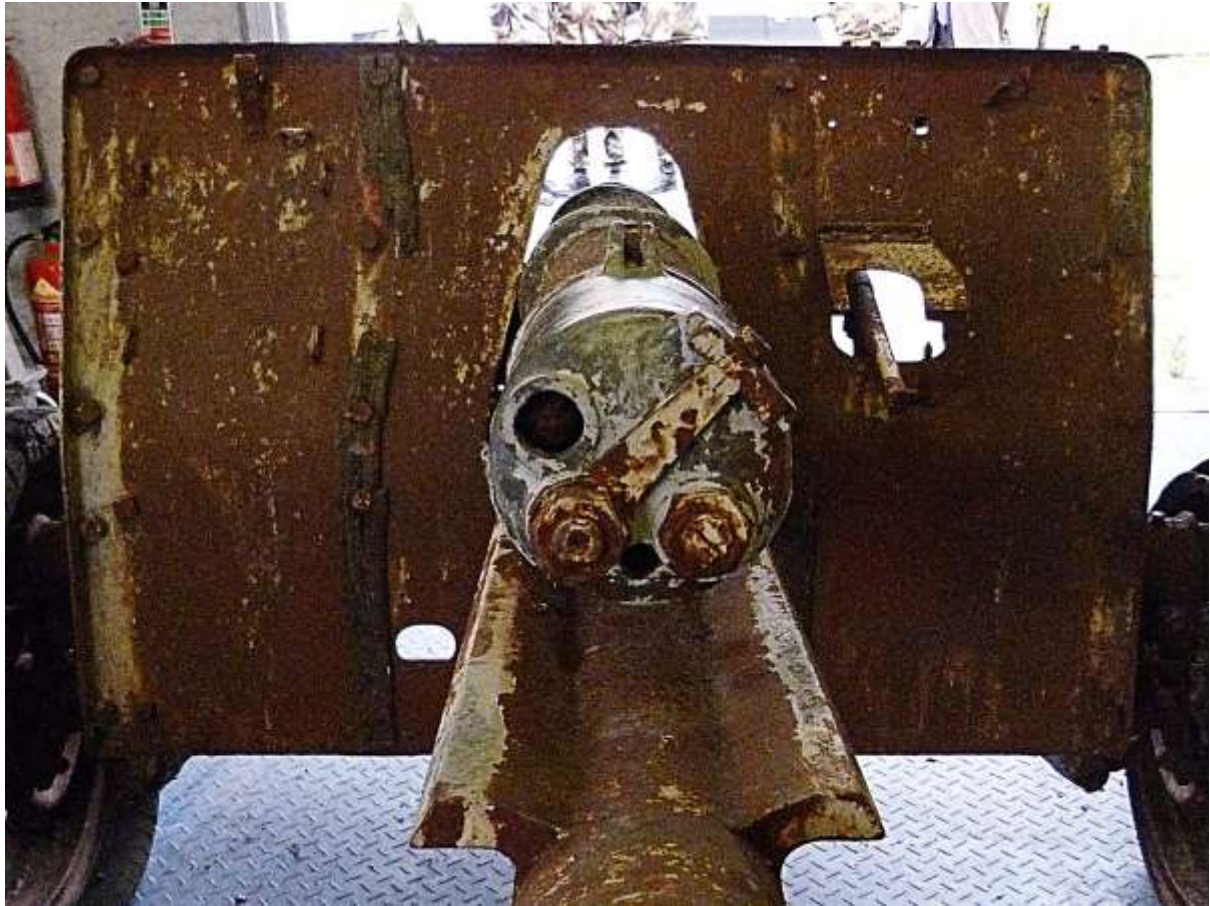
Figure 29 front of the shield

The front of the shield is also in a similar condition to the back, with heavy corrosion but less degraded paint, the leather is also degraded and if required for display would have to be replaced because of the poor condition. The hatch for the rammer is also corroded with active pitting corrosion; the rammer is believed to be missing. (See figures 29 and 30)

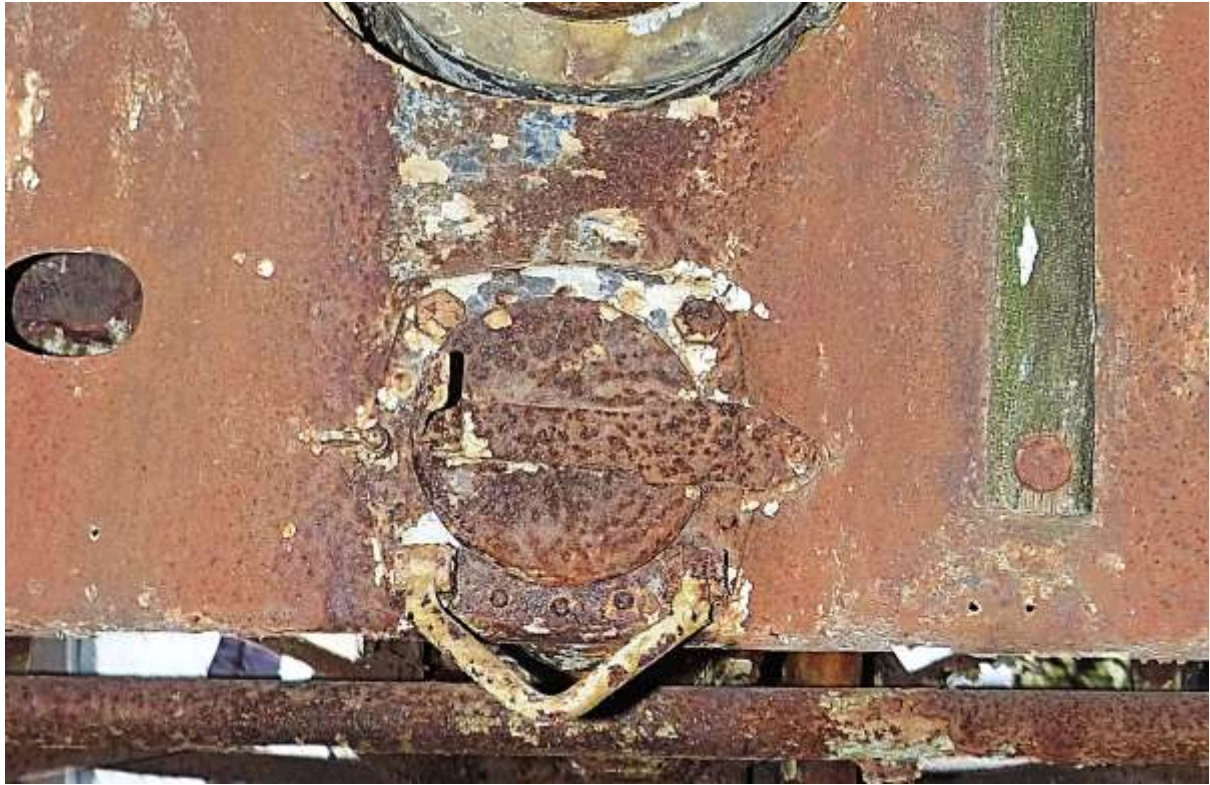
Figure 30 the hatch for the ramrod.

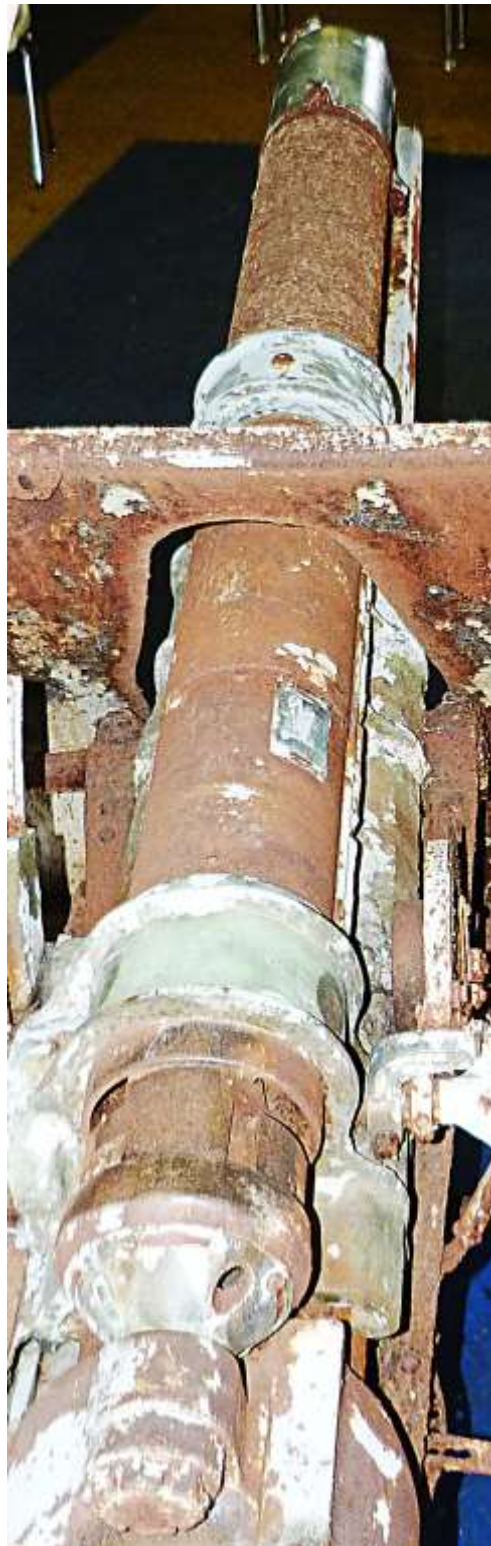
Figure 33 the recoil

The recoil is in poor condition with the steel work corroded and the brass work overpainted and the rope round the recoil is missing and should be replaced.

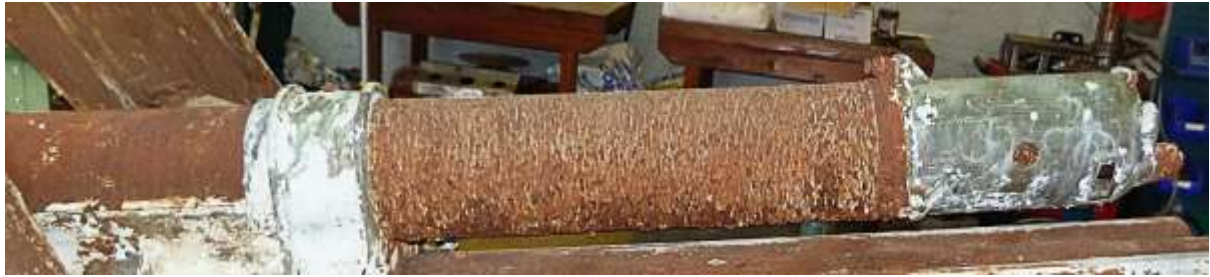
Figure 34 the recoil from the proper right side
