British WW 1 18 Pound Quick Firing Field Gun

Irish Army Civil War Artillery

Condition report

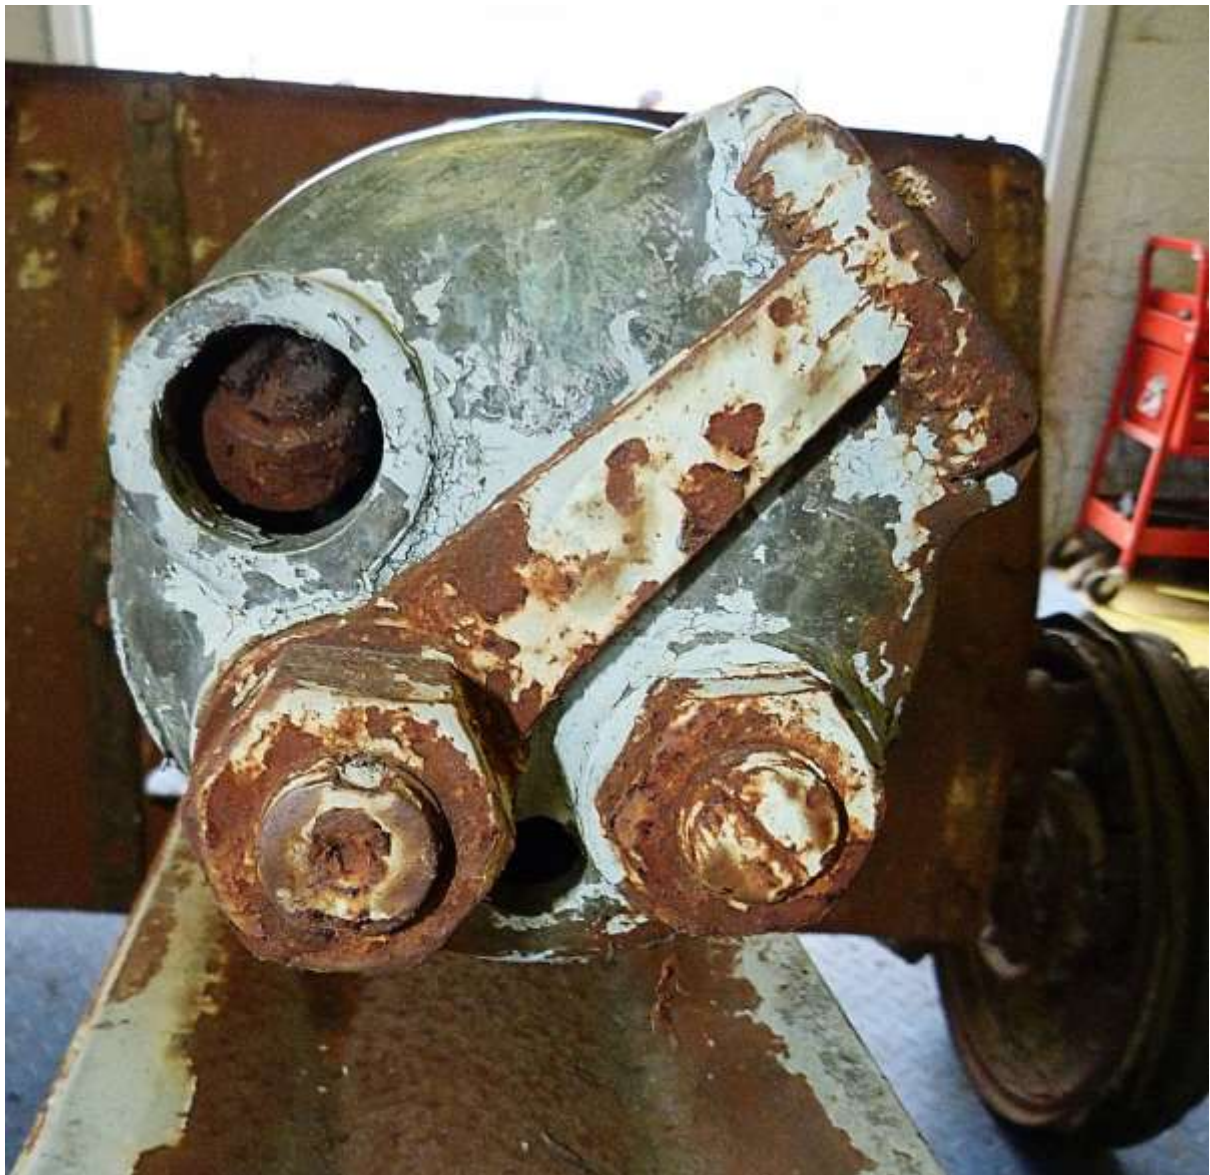
In addition, one of the fixings on the front appears to have pushed back into the recoil unit, the rest of the fixings on the front appear to be corroded and misshapen. The rest of the fixings are also in poor condition and the recoil and barrel are possibly fused together and on the carriage.

Figure 35 the front of the recoil

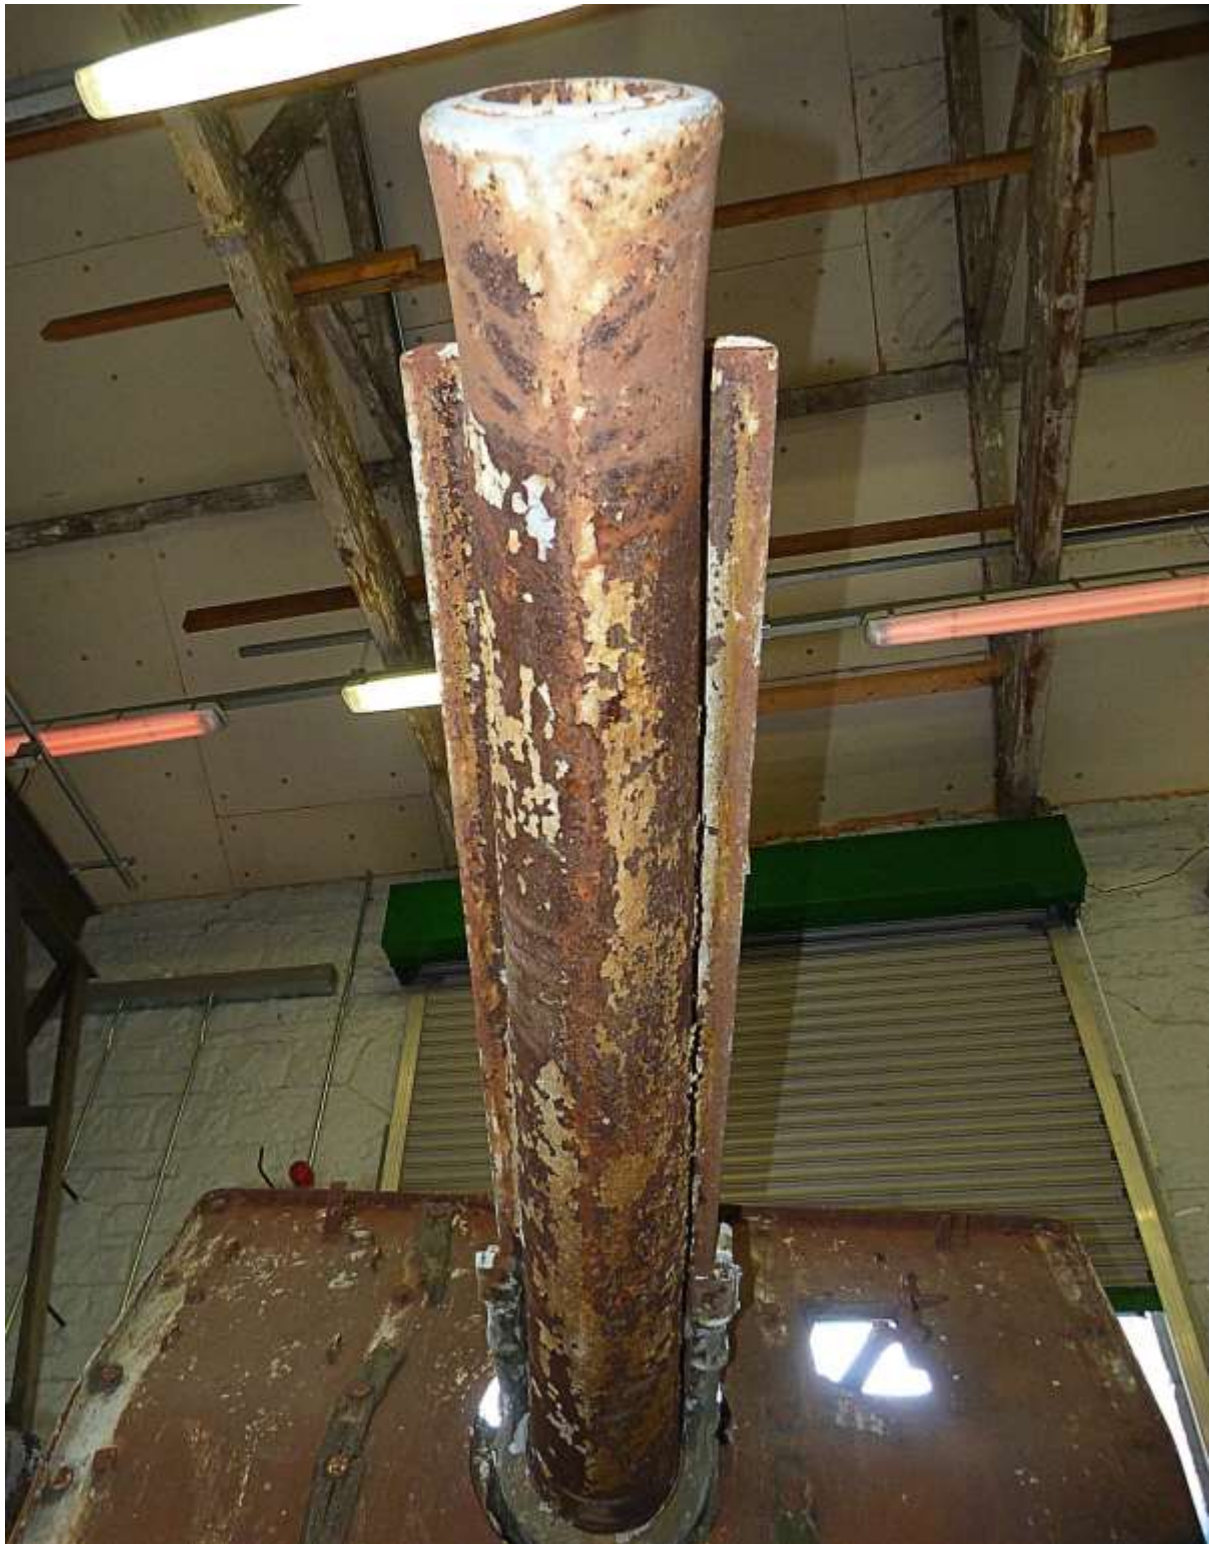
Figure 36 the underside of the barrel

The barrel is heavily corroded and again degraded paint is present the corrosion has caused loss of material this is more noticeable on the underside. (See figure 36.) The fixings to the recoil and carriage are also in poor condition as previously mentioned the recoil and barrel poor condition might result in difficulty separating them for treatment, this could mean that is not possible to use blast media.

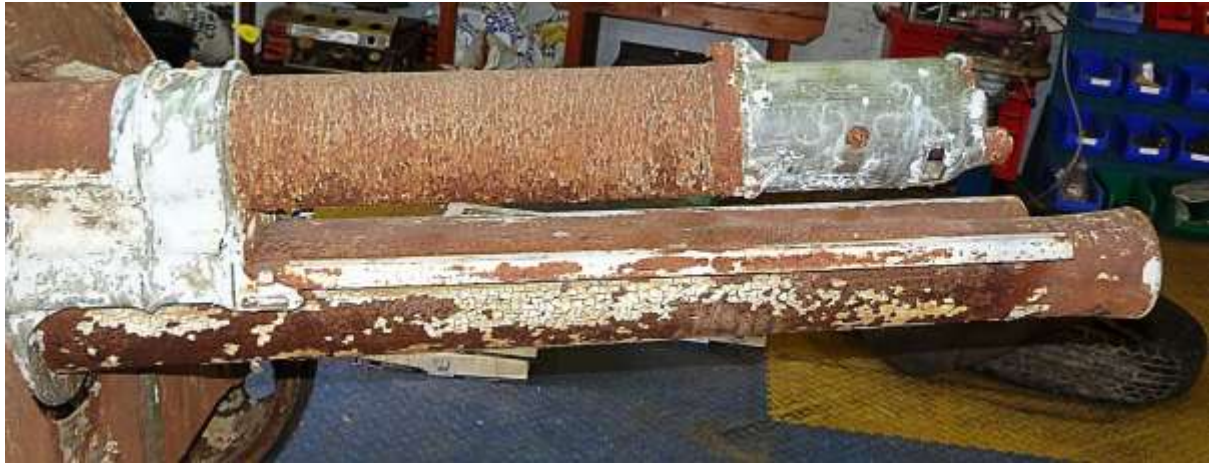
Figure 37 the barrel under the recoil

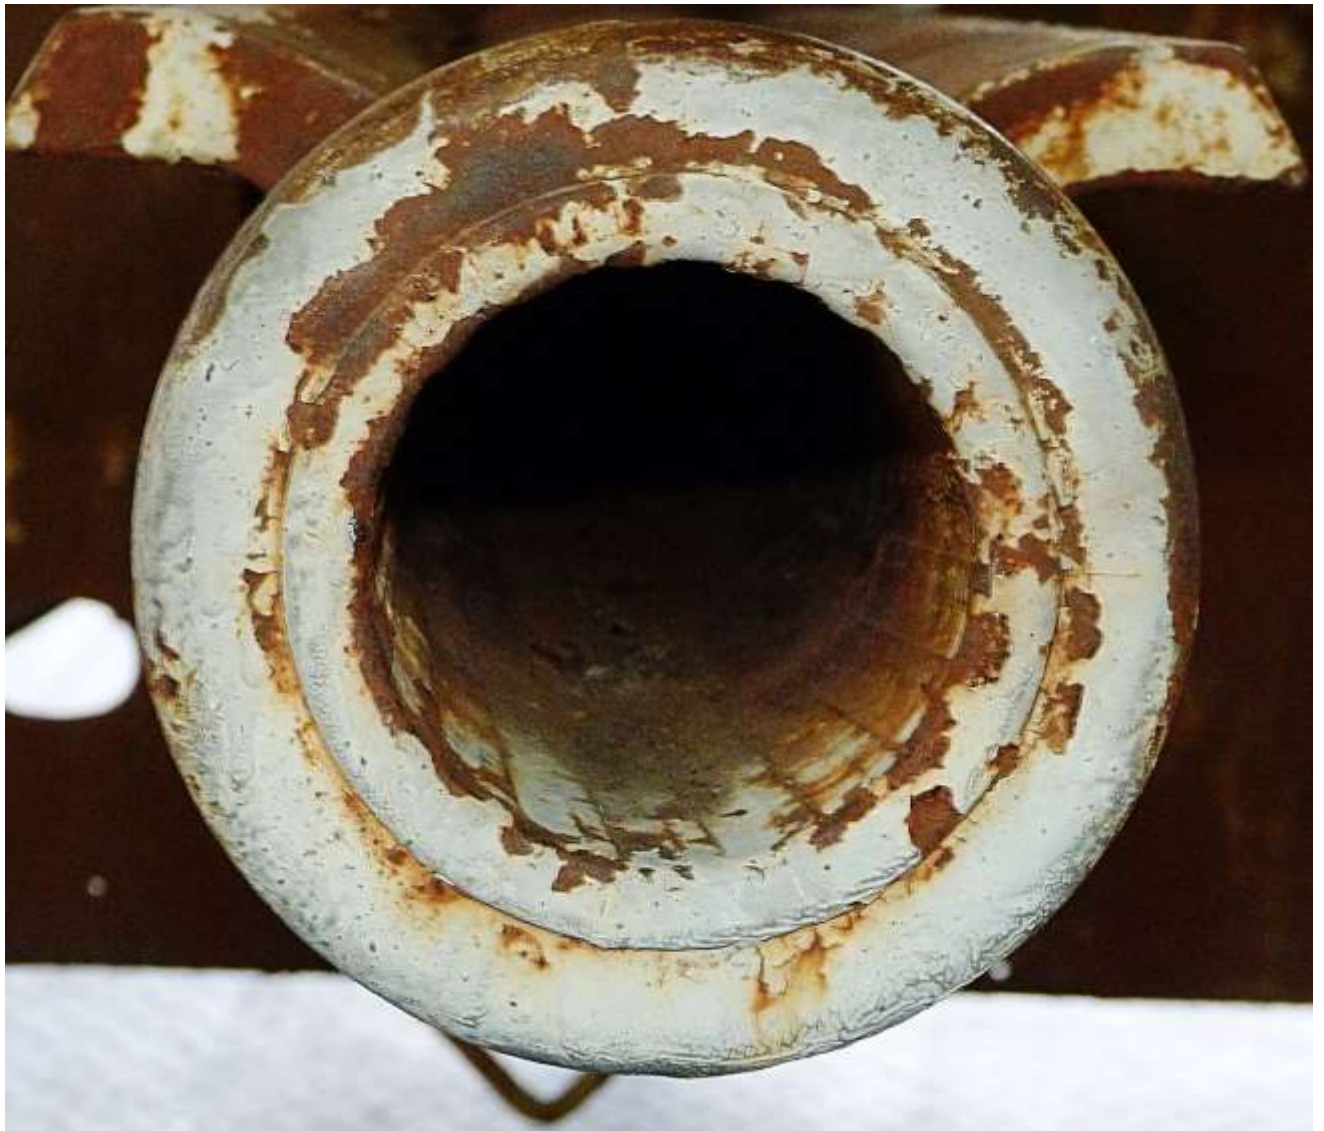
Figure 38 the inside of the barrel

The inside of the barrel has not been fully inspected with a bore scope but the muzzle end that is visible has an even coating of corrosion and some degraded paint. The corrosion would probably extend down the length of the barrel inspection during treatment with a bore scope would be desirable. (See figure 38)

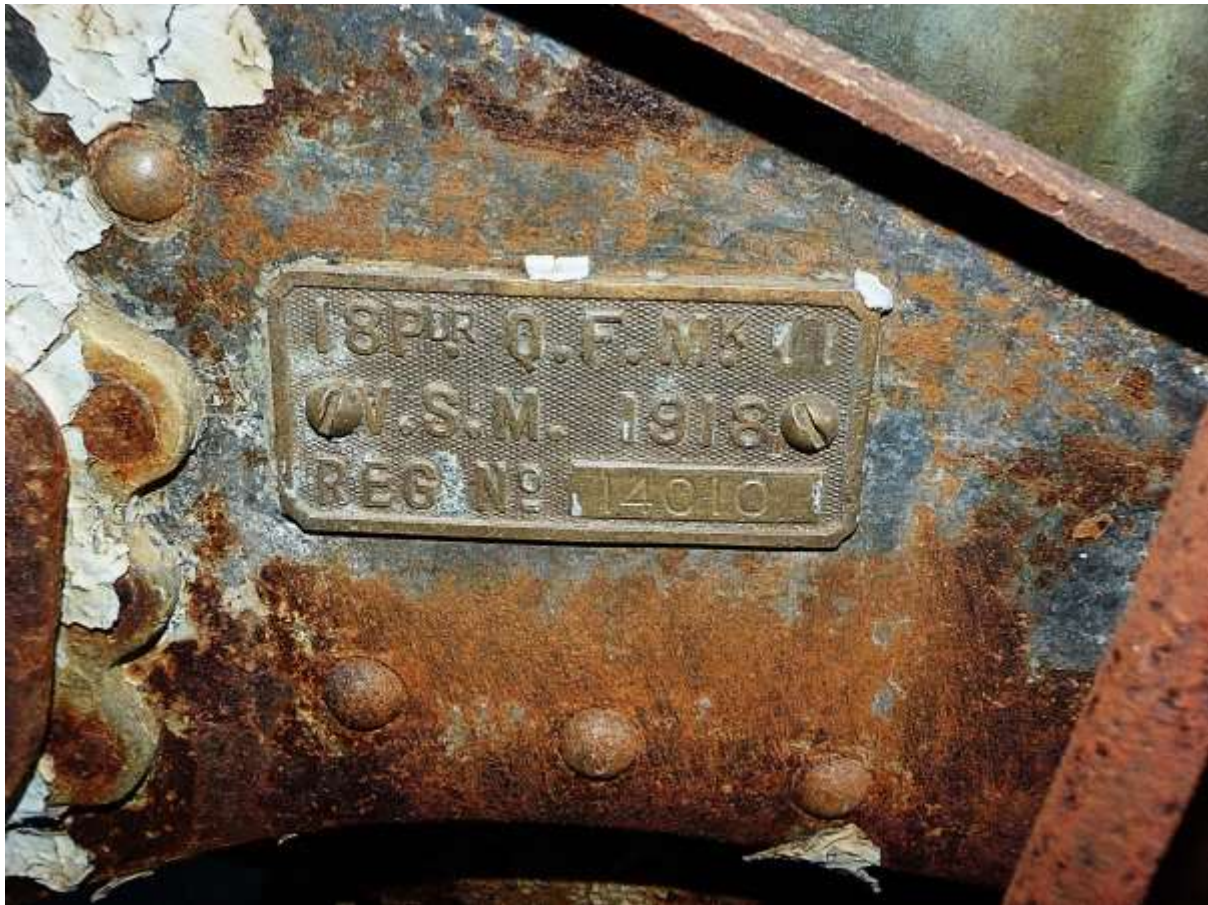
Figure 39 The makes label on the carriage

The rest of the carriage suffers from the same problems of corrosion degrading paint, seized and misshapened fixings. It should also be noted that the carriage has a different maker's name to the barrel this is not uncommon in artillery as the parts were interchangeable. This will not affect the integrity of the object as it is possible that this is the original carriage as current research suggests William Beardmore and Company Glasgow only made the 18pr barrels and not carriages, also the date is the same as the barrel. However, Vickers Sons and Maxim (V.S.M.) manufactured both carriages and barrels. This is a historical research question that could benefit from further investigation. (See figure 39) Some other objects that have markings can be a cause for concern an example would be clock movements in a non original case.
