British WW 1 18 Pound Quick Firing Field Gun

Irish Army Civil War Artillery

Condition report

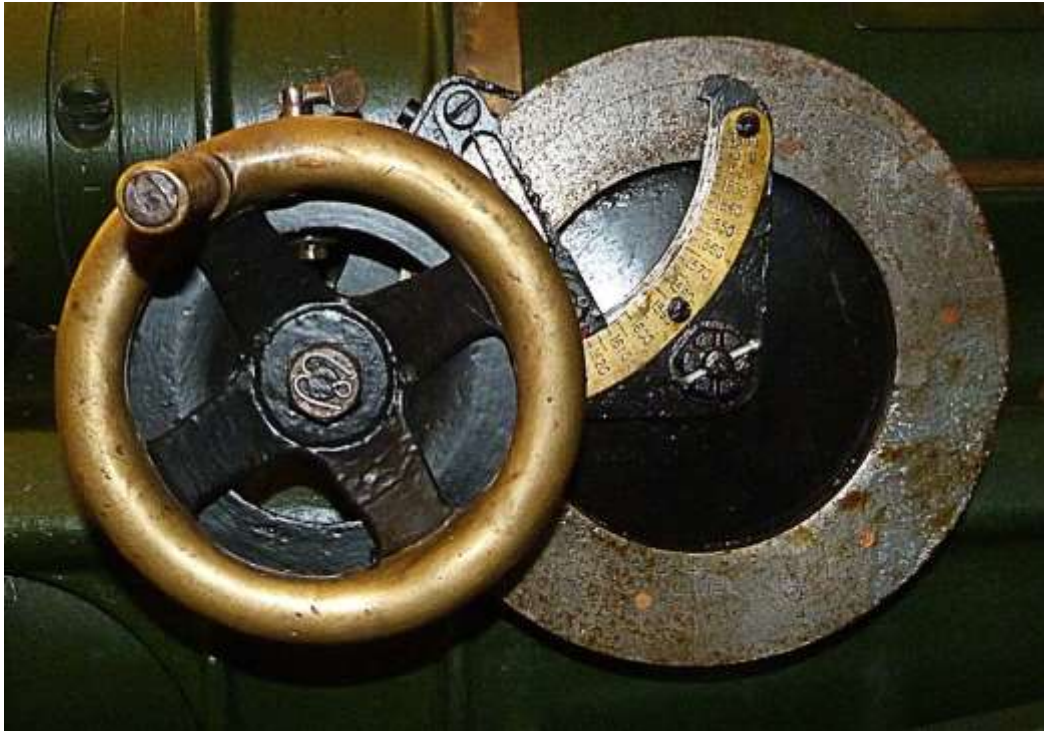
The range scale and hand wheel are in poor condition, the range scale steel wheel is corroded to such an extent that retrieving the scale might be beyond current conservation methods. If this is the case and with the level of surface pitting it would appear that it is, then a replica could be created for display and the current range scale treated and stored with the gun. (See figure 20 the elevating range scale and 21 a restored range scale on a different WW1 18Pr.) The bass arm with an elevating scale engraved on it should return to as near service condition with conservation treatment currently this is overpainted; therefore; the condition rating is poor, the same goes for the hand wheel on elevating range scale mechanism.

Figure 22 a restored range scale on a different WW1 18Pr

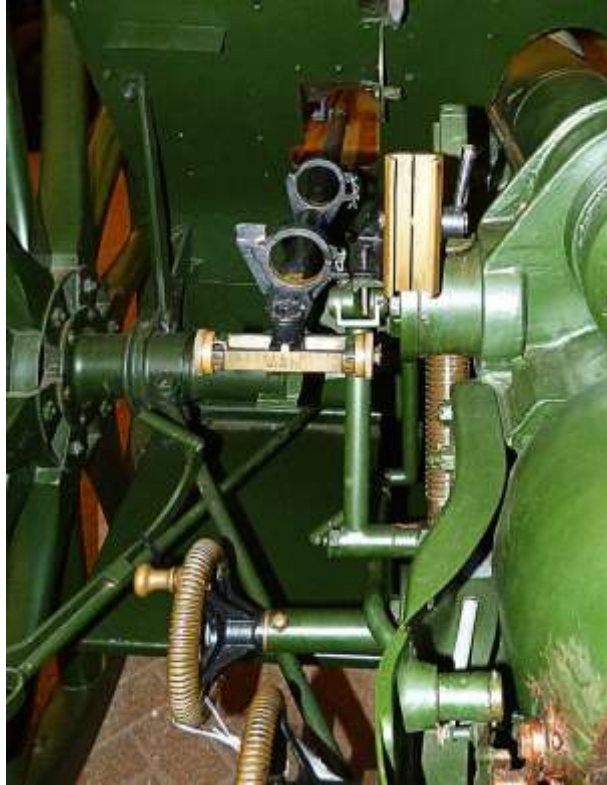
The sights rests are in poor condition similar to the range gauge mechanism with steel parts heavily corroded and the brass parts heavily overpainted. The same treatments as the range gauge mechanism to improve the condition of these parts to museum/historic object standard is required. (See figures 23 and 24 for conserved sight rest on a different 18Pr)

Figure 24 the sight rests

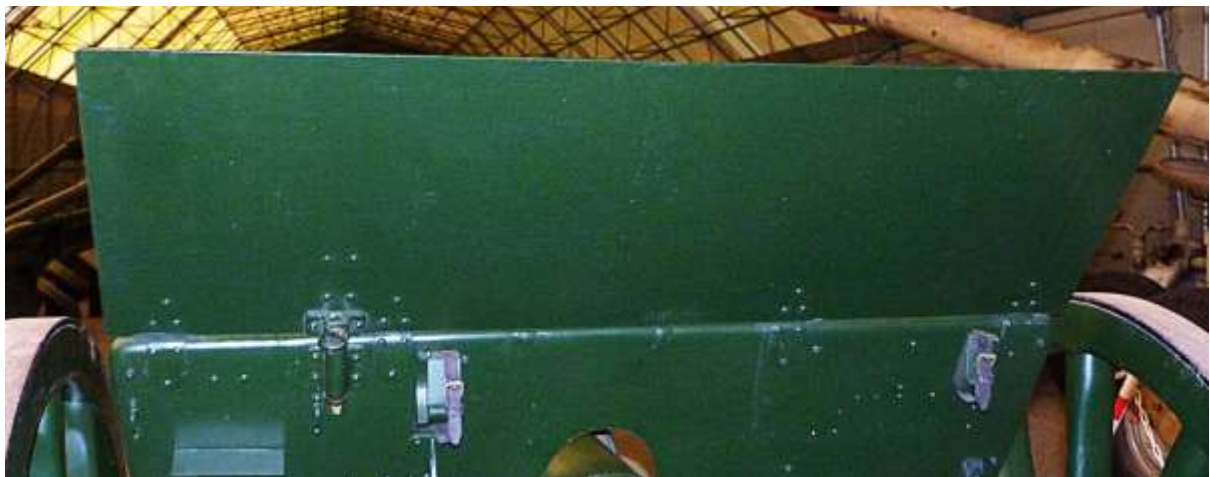
The shield also has two parts missing two extensions one on the top that folds down one the front and one on the bottom that folds up. Replicas of these parts could be considered for display if required. (See figures 31 and 32 for shield extensions on a different gun)

Figure 31 top extension on a different gun

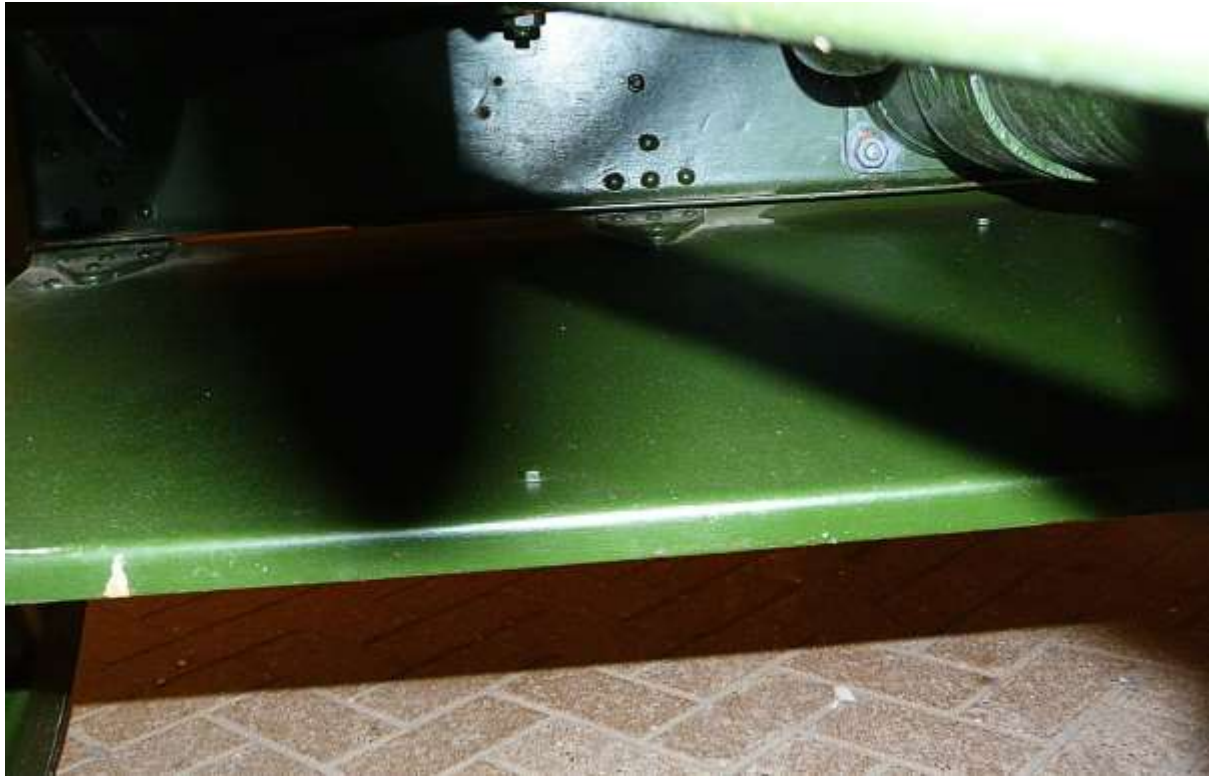
Figure 32 the lower extension on a different gun
